A study of supercharger belt failures

An engineering approach to understanding and solving the problem of broken supercharger drive belts

by Jim Shepherd, Manager Power Transmission Product Application The Gates Rubber Company

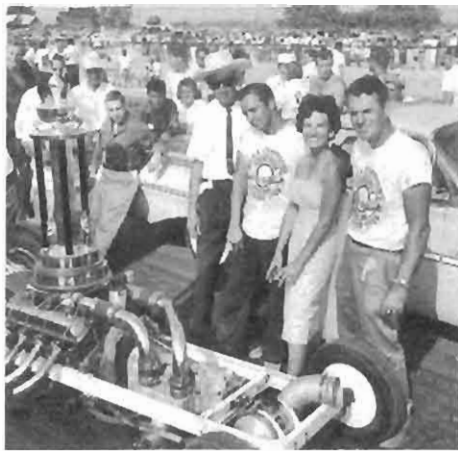
Fig. 1

Many early blower-drive units were driven off the front of the engine. A good example is the blown Lincoln that Rodney Singer took to the '59 U.S. Nationals title.

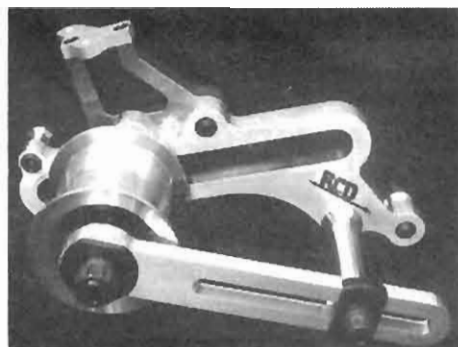
Fig. 6

An outboard support device can help reduce belt tension across the idler.

that the belt tension across the idler is more than 1,000 pounds during the starting operation — and this is assuming a smooth start! Tension of this magnitude is considered significant because many of the idler brackets appear to be rather low in strength and are heavily cantilevered. Recently, outboard support devices have been offered; they are highly recommended for this application (Fig. 6).

Idler bracket and geometry — Because of the large number of observed problems with idlers (bending, loosening, and misalignment), it is strongly suggested that the idler bracket be of the modern high-strength design, including an out-board support.

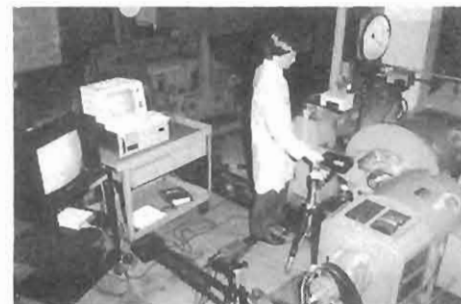
Fig. 8

The electric dynamometer is used for testing the various blower pulleys, belt-construction variables, and belt tensioning.

The equipment used for dynamic testing was an electric dynamometer (Fig. 8). This is a highly sophisticated testing apparatus combined with a high-resolution video camera and computer data-acquisition equipment. Belts were tested at torque loads similar to the application, corrected for belt width.

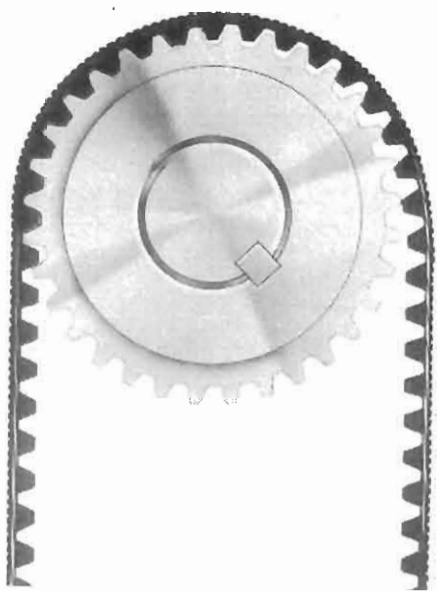
Fig. 9

Illustrated is belt rideout, where the blower belt ratchets on the pulley, resulting in skipped teeth.

What does all this mean? A loosely tensioned belt does not reduce the shaft loads on the crank and blower at race operating conditions. It does, however, produce a condition where the belt is very close to ratcheting. On the actual application, where the shafts are not as rigid and the operating conditions are considerably more severe than those created by the laboratory equipment, it is quite likely that the belt can and will ratchet.

It is our opinion that the vibration and tooth shear noted by Bernstein and Prudhomme are the result of belt ratcheting.

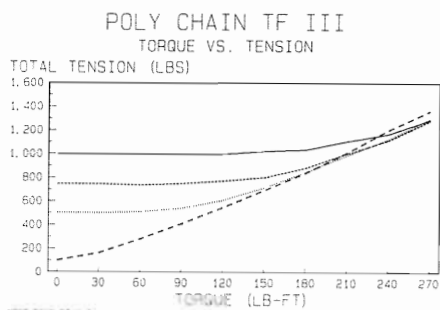
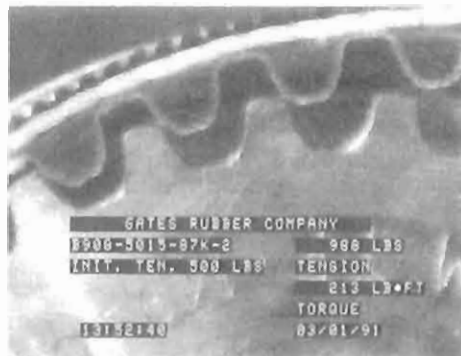
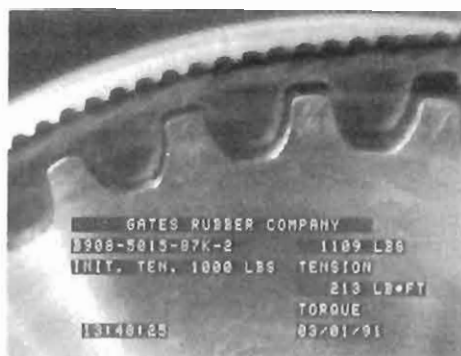
Figs. 10-14

A high-resolution video camera catches the blower belt on a torque-producing pulley at various stages of installation tension. The torque versus tension curve is above left.

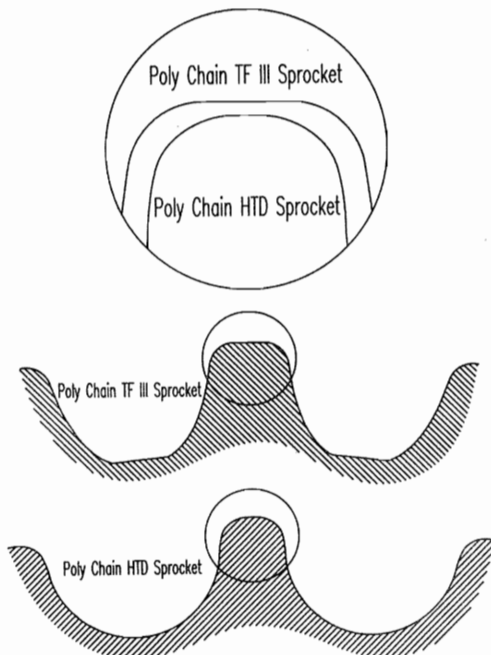
Fig. 16

The new geometry of the 112-tooth TF III system is compared with the older 111-tooth HTD system below. The TF III is based on a gear profile that produces uniform tooth loading and tensile-cord load distribution.

By far the most dramatic impact on belt performance is the change from the original 111-tooth belt configuration to the new 112-tooth TF III belt. The original 111-tooth belt was based on the HTD profile. The TF III belt takes advantage of a new tooth-profile system (U.S. patent 4,605,389). In addition, it is designed around a further tensile-cord improvement (U.S. patent 4,652,252). With these two new advancements, the TF III belt has vastly different characteristics with even higher tensile strength and tensile modulus (compared to the upgraded 111-tooth HTD belt), plus a significantly improved belt-and-sprocket system. The new geometry of the TF III system is compared with the HTD system in Fig. 16. The TF III is based on a gear profile that produces uniform tooth loading and tensile-cord load distribution.

One further benefit is that the new system has about 40 percent less backlash (i.e., clearance between the back of the tooth and the sprocket). This is believed to help reduce the damage caused by the torsionals on the belt.
